2015/2016 Annual Inspection Report

FRESHWATER INTRODUCTION SOUTH OF HWY 82 PROJECT (ME-16)

State Project Number ME-16
Priority Project List 9

November 05, 2015
Cameron and Vermilion Parishes

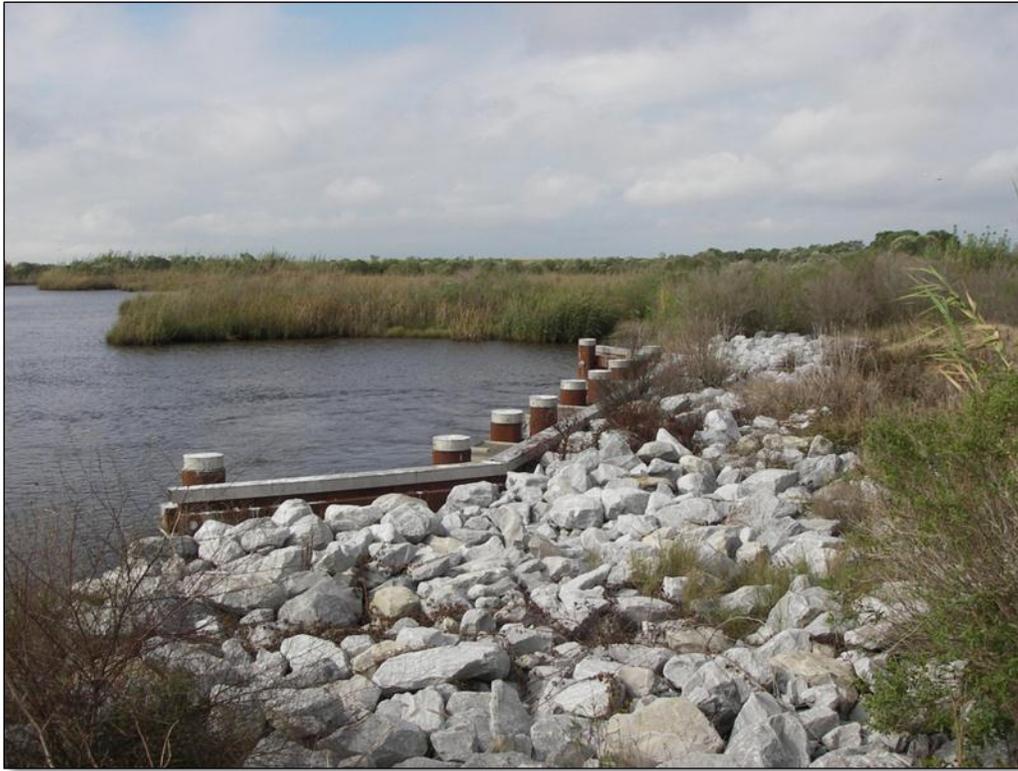
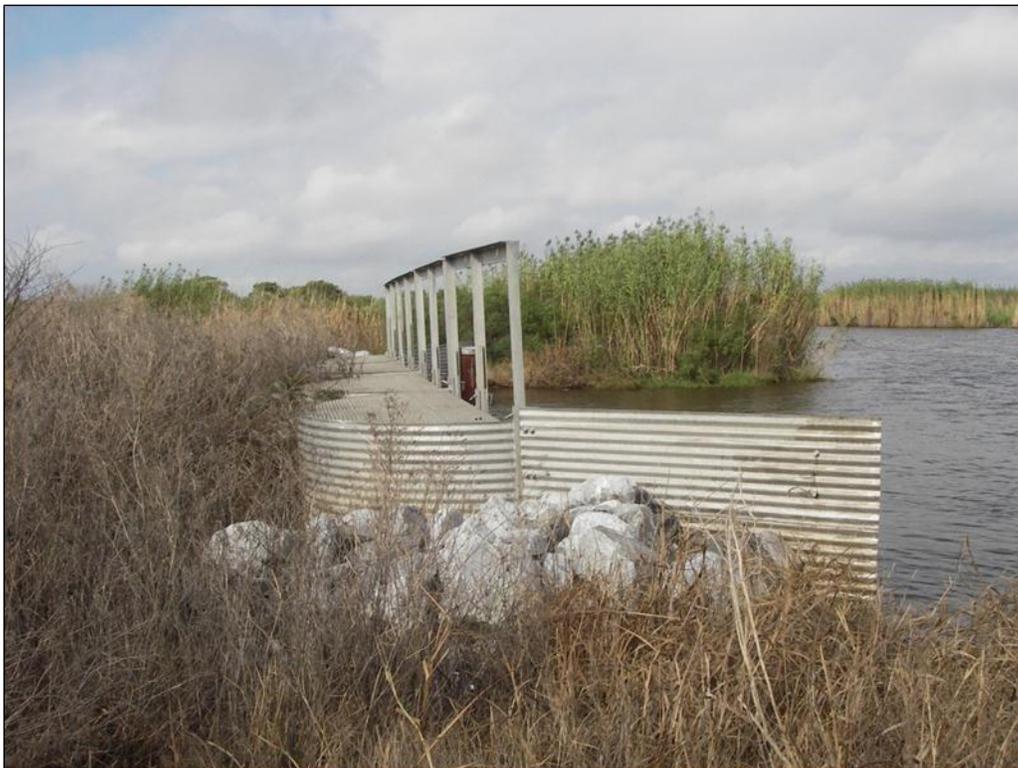
New Cop-Cop Structure

The structure is in good condition. Rock revetment looks good. (Photos: Appendix B, Photos 1 & 2)

Photo No. 1, New Cop-Cop Structure, outlet side of structure.

Photo No. 2, New Cop-Cop Structure, inlet side of structure.

Item	Condition	Physical Damage	Corrosion	Photo #	Observations and Remarks
Flapgates	Good				
Steel Grating	Good				
Stop Logs	Good				
Hardware	Good				
Timber Piles Timber Walkway	Good				
Timber Wales	Good				
Galv. Pile Caps	Good				
Culverts	Good				
Signage /Supports Staff Gages	N/A				
Rip Rap (fill)	Good			1 & 2	
Earthen Embankment	Good

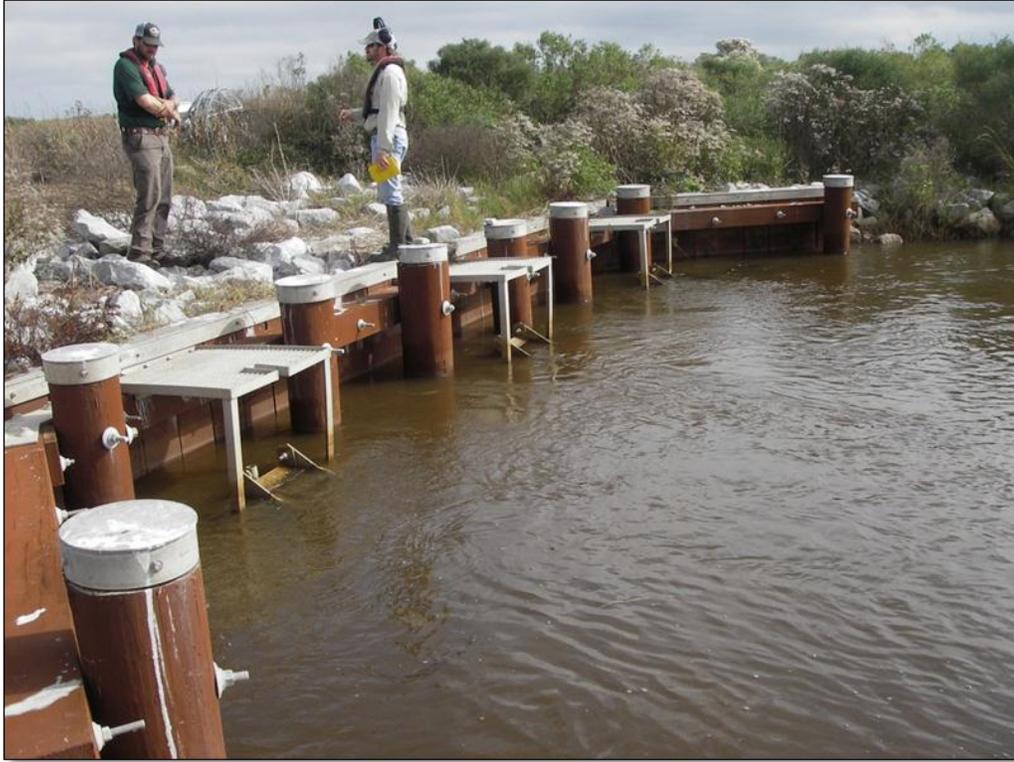
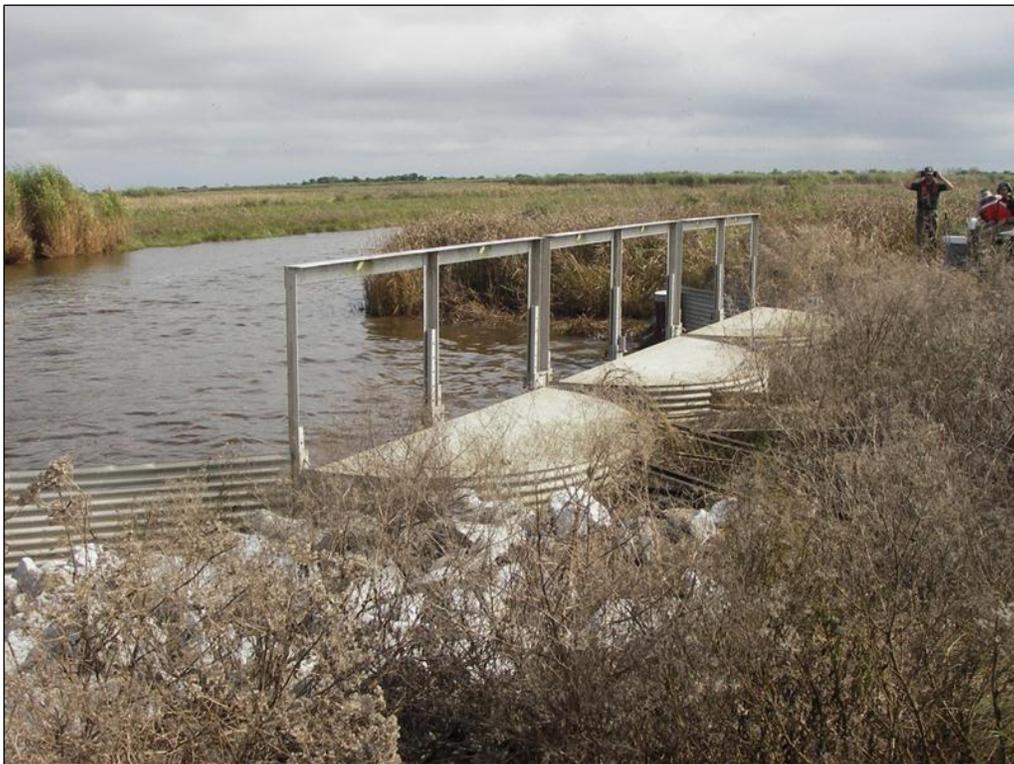
Perry Bayou Structure (Formerly Structure No. 12)

Overall this structure is in good condition. Rock revetment looks good. (Photos: Appendix B, Photo 3 & 4)

Photo No. 3, Perry Bayou Structure, outlet side of structure.

Photo No. 4, Perry Bayou Structure, inlet side of structure.

Item	Condition	Physical Damage	Corrosion	Photo #	Observations and Remarks
Steel Bulkhead / Caps	N/A				
Steel Grating	Good				
Stop Logs	Good				
Hardware	Good				
Timber Piles	Good				
Timber Wales	Good				
Galv. Pile Caps	Good				
Cables	N/A				
Signage / Supports / Staff Gages	N/A				
Rip Rap (fill)	Good			3 & 4	
Earthen Embankment	Good			3 & 4

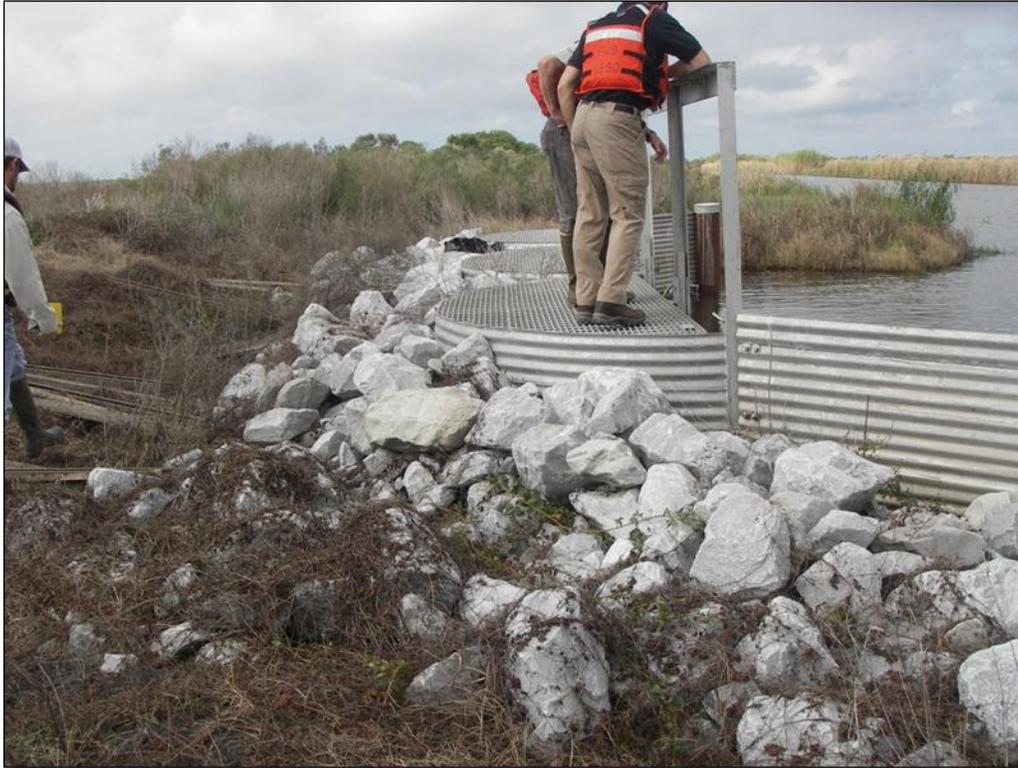
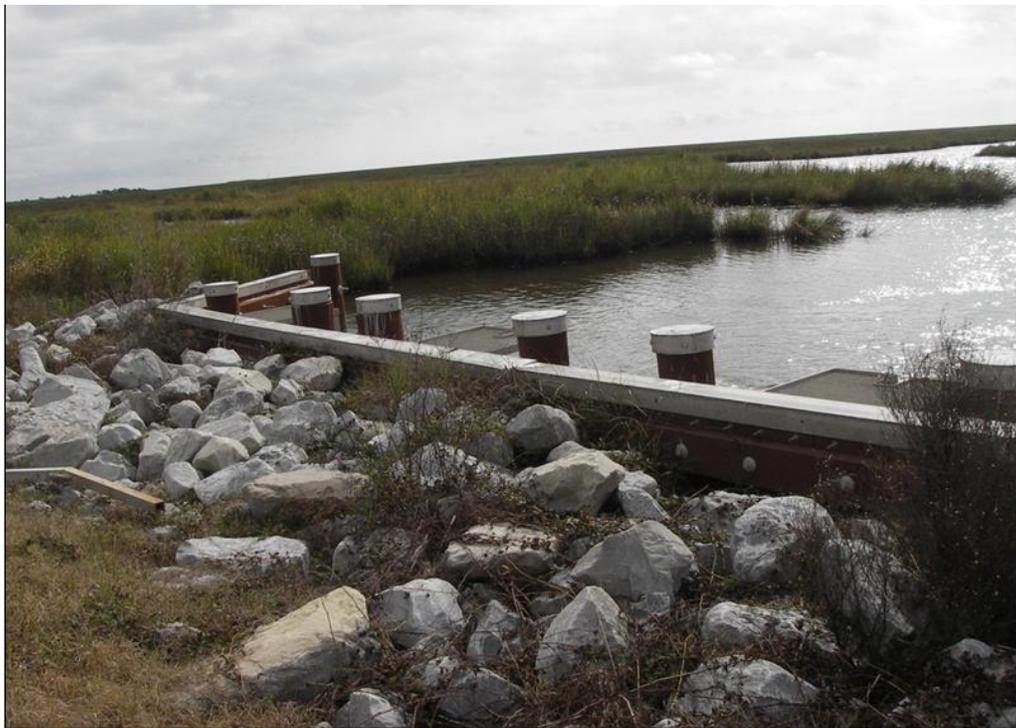
McNeese Bayou Structure (Formerly Structure No. 10)

Overall this structure is in good condition. Rock revetment looks good. (Photos: Appendix B, Photo 5 & 6)

Photo No. 5, McNeese Bayou Structure, inlet side of structure.

Photo No. 6, McNeese Bayou Structure, outlet side of structure.

Item	Condition	Physical Damage	Corrosion	Photo #	Observations and Remarks
Flapgates	Good				
Steel Grating	Good				
Stop Logs	Good				
Hardware	Good				
Timber Piles Timber Walkway	Good				
Timber Wales	Good				
Galv. Pile Caps	Good				
Cables	N/A				
Signage /Supports Staff Gages	N/A				
Rip Rap (fill)	Good			5 & 6	
Earthen Embankment	Good			5 & 6

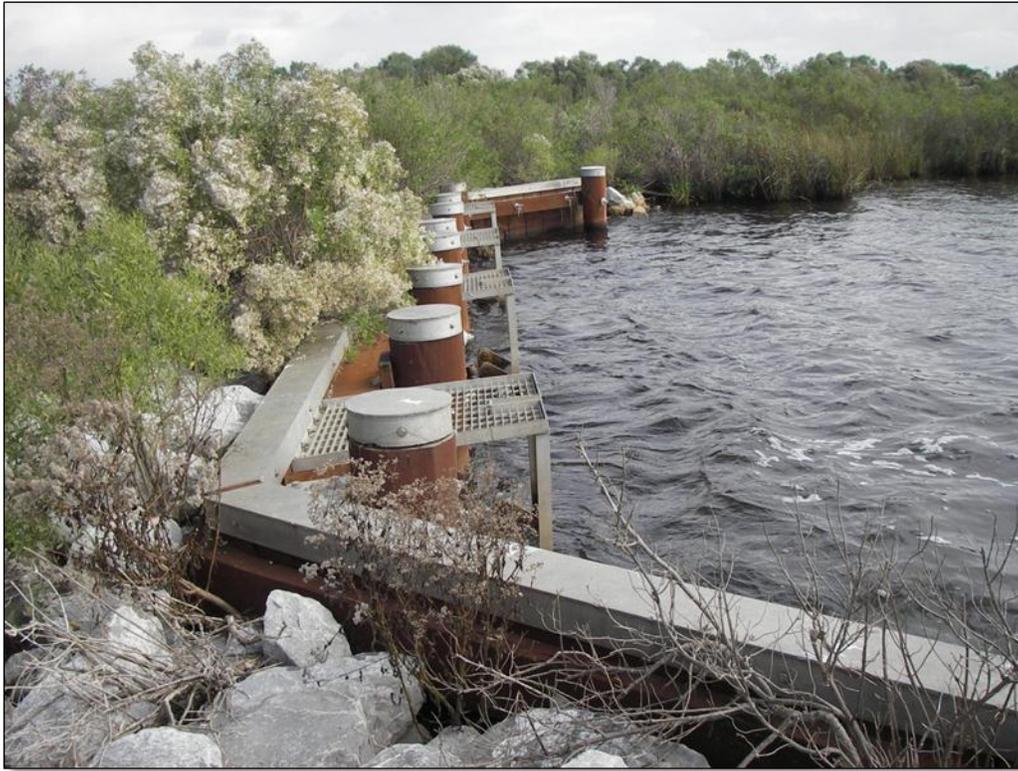
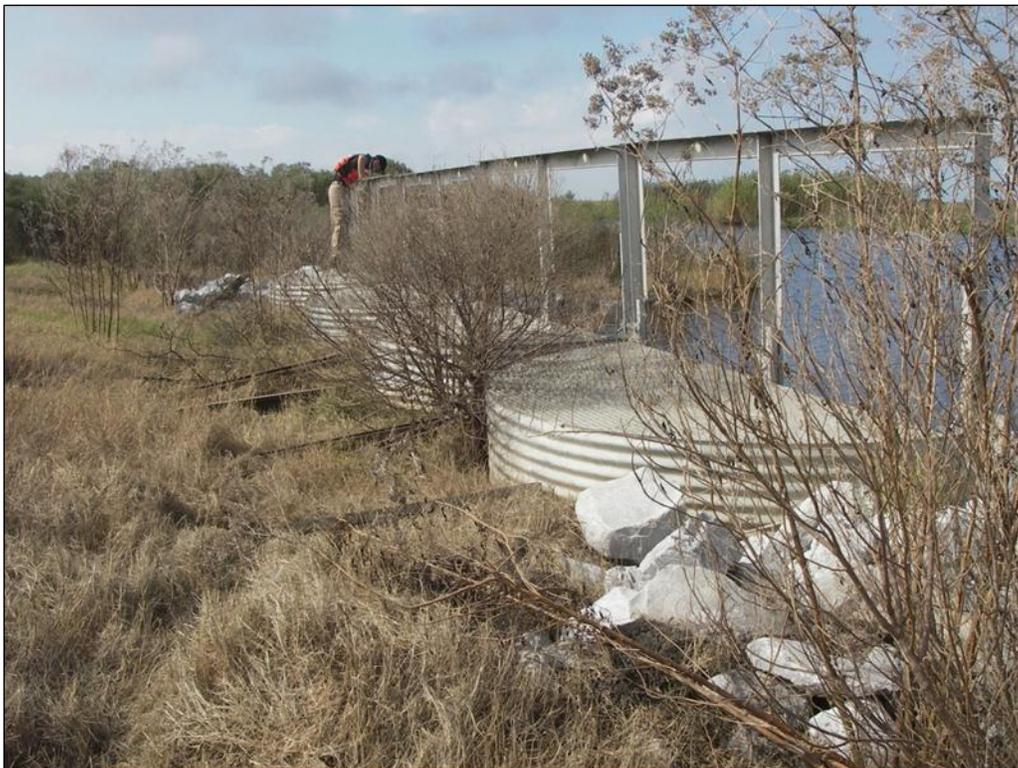
Hess' Cut (Formerly New Dyson Structure)

Overall this structure is in good condition. Rock revetment looks good. (Photos: Appendix B, Photo 7 & 8)

Photo No. 7, Hess' Cut Structure, outlet side of structure.

Photo No. 8, Hess' Cut Structure, inlet side of structure.

Item	Condition	Physical Damage	Corrosion	Photo #	Observations and Remarks
Flapgates	Good				
Steel Grating	Good				
Stop Logs	Good				
Hardware	Good				
Timber Piles Timber Walkway	Good				
Timber Wales	Good				
Galv. Pile Caps	Good				
Culverts	Good				
Signage /Supports Staff Gages	N/A				
Rip Rap (fill)	Good			7 & 8	
Earthen Embankment	Good			7 & 8

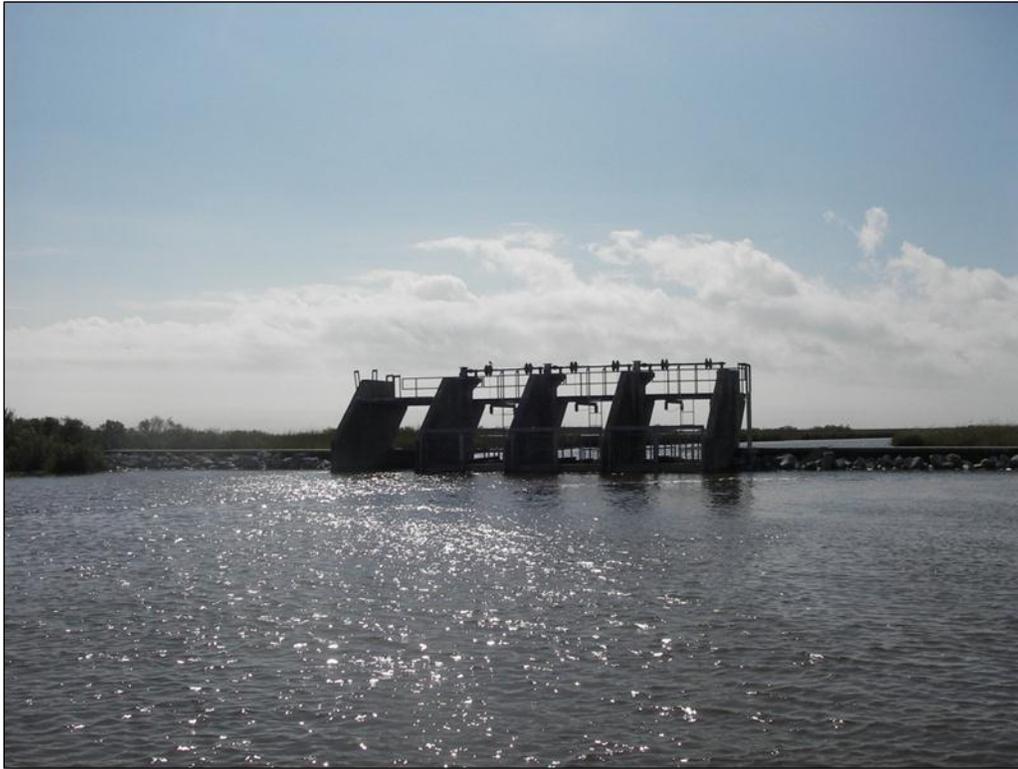
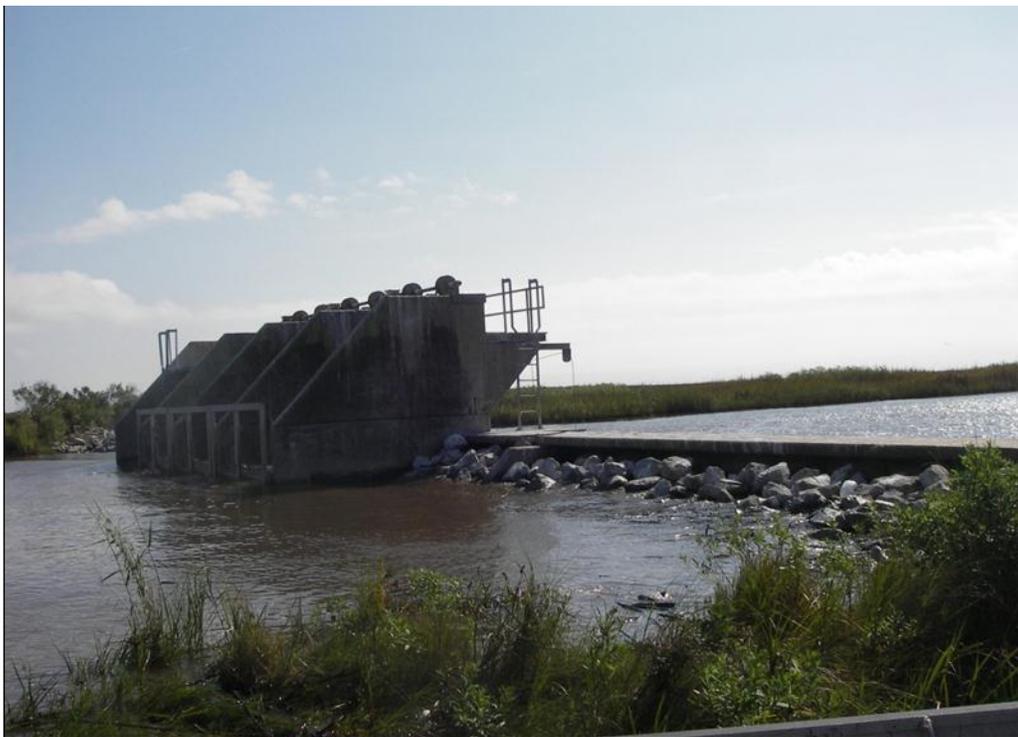
Overall this structure is in good condition. Rock revetment looks good. (Photos: Appendix B, Photo 9 & 10)

Photo No. 9, Little Constance Structure

Photo No. 10, Little Constance Structure, west side of structure.

Item	Condition	Physical Damage	Corrosion	Photo #	Observations and Remarks
Concrete Control Structure	Good				
Flap Gates	Good				
Stop Logs	Good				
Hardware	Good				
Timber Piles Timber Walkway	N/A				
Timber Wales	N/A				
Galv. Pile Caps	N/A				
Cables	Good				
Signage /Supports Staff Gages	N/A				
Rip Rap (fill)	Good			9 & 10	
Earthen Embankment	N/A
